# 溶鋼鍋側壁キャストブルにおけるリング拘束熱衝撃試験の検討

## Study of ring-constrained thermal shock test on castables for ladle

In order to evaluate samples by a thermal shock test simulating the high constrained condition of a ladle in a laboratory scale, we conducted a ring-constrained thermal shock test that is comparatively simple method. As a result, it was found that vertical crack with 180°symmetry on the heating surface, parallel crack near the heating surface, and vertical crack on the back surface were generated in the ring sample, which were consistent with the actual after-use side wall products in ladle. The results of the FEM analysis showed that high stresses were generated at the each crack locations, and it was estimated that differences of stress durability and crack propagation were related to the size of each crack.

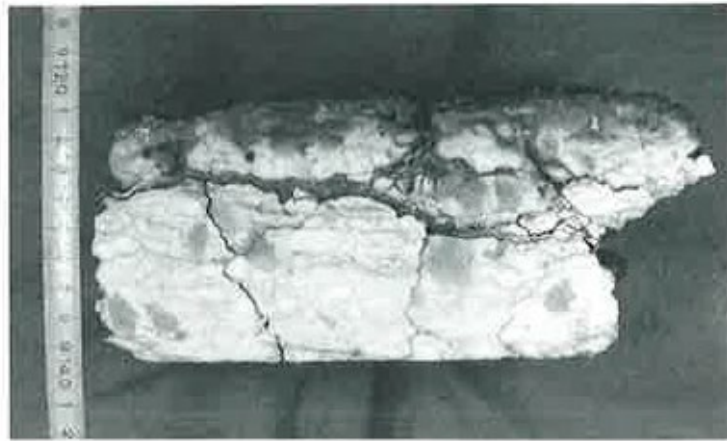
**Fig. 1 Cross section of alumina-magnesia castable after using.**<sup>1)</sup>  
(The upper side of the image is the hot surface)

取鍋側壁キャストブルは、稼働中に亀裂・剥離が繰り返し発生し、これが損耗の主要因となっている。図1に示すように、発生する亀裂は主に、稼働面に対して垂直な亀裂が稼働面側および背面（鉄皮側）から発生し、稼働面に対して平行な亀裂が側壁材内部に発生する。稼働面側および背面から発生した垂直な亀裂は取鍋背面における地金差しの原因となり、側壁材内部に発生した平行な亀裂は剥離の原因となる。特に後者の平行な亀裂は剥離を引き起こすため、図2のように側壁材を大

Ladle sidewall castables receive damage due to generation of crack and spalling during operation. As shown in Fig. 1, the cracks mainly occur vertical to the heating surface from the heating surface side and back (steel shell) side, in addition, parallel cracks to the heating surface occur inside the sidewall material. Vertical cracks that occur from the heating surface side and from the back side cause skull penetration on the back side of the ladle, while parallel cracks occurred inside the sidewall material cause spalling. In particular, as shown in Fig. 2, the parallel cracks cause spalling, which leads to significant damage to the sidewall material. Therefore, their cracks

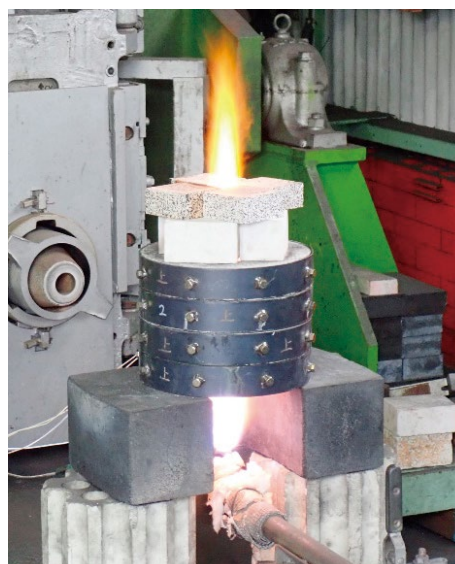
Fig. 4 Experimental set up of ring-constrain thermal shock test.

図4に作製したリング状サンプルを用いて熱衝撃試験を実施した様子を示す。熱衝撃試験はリング状の金枠を付けたまま、サンプルの外側を拘束した状態で行った。図4に示すように、作製したサンプルを4段重ね、中心側の面(加熱面)を、ガスバーナーを用いて1600℃まで1hで急加熱することにより熱衝撃を与え、その後放冷した。また、試験中の温度を測定するために、加熱面側及び背面側に熱電対を設置し、サンプルの温度データを記録した。

Figure 4 shows the ring-restrained thermal shock test conducted on the produced ring-shaped sample. The thermal shock test was carried out with the ring metal frame attached and the outside of sample constrained. As shown in Fig. 4, four layers of ring samples were stacked, and these samples were given a thermal shock by rapidly heating the center side (heated surface) to 1600℃ for 1 h using a gas burner, and then cooling at room temperature. In addition, thermocouples were set up on the heating surface side and on the back side to measure the temperature during the test, and the temperature data of the samples were recorded.

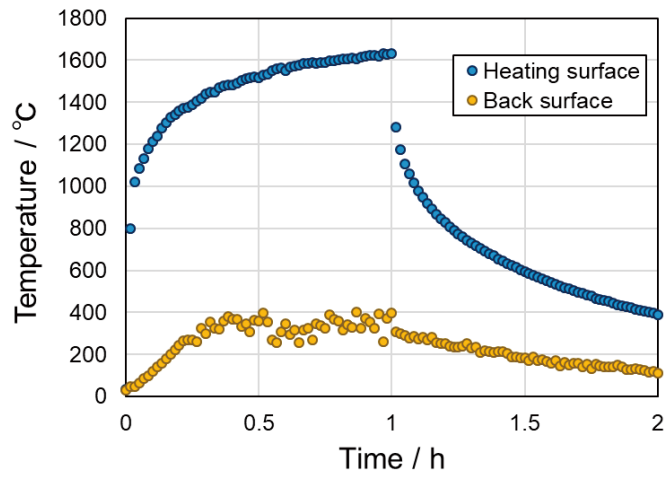
**Fig. 6** Temperature changes of heating and back surfaces during the ring-constrain thermal shock test.

測温結果を図6に示す。加熱面側は約1600℃、背面側は約400℃まで上昇していることが分かった。図7にリング拘束熱衝撃試験後の各サンプルのDICMによるひずみ分布画像を示す。すべてのサンプルにおいて加熱面から大きい垂直な亀裂①が発生し、この亀裂は180°対称方向に発生することが分かった(図8(c)①)。また、上から1, 3段目のサンプルに見受けられるように、リングサンプルの背面(鉄皮側)から垂直な亀裂が発生していることが確認された。

Figure 6 shows the temperature measurement results. The temperature of the heating surface side increased to about 1600°C, and the back side increased to about 400°C. Figure 7 shows DICM strain distribution images of each sample after the ring-constrained thermal shock test. Large vertical crack (1) from the heating surface were observed in all samples, and these cracks generated in 180° symmetrical directions (Fig. 8(c)(1)). In addition, as shown in the first and third samples from the top, vertical cracks from the back (steel shell) side of the ring sample were observed.

In order to investigate the mechanism of these crack initiation, Finite Element Method (FEM) analysis was carried out using the temperature measurement data (Fig. 6) at the heated surface and the back surface in the thermal shock test. As shown in Fig. 9, the FEM analysis was conducted using an axisymmetric model for unsteady-state thermal stress

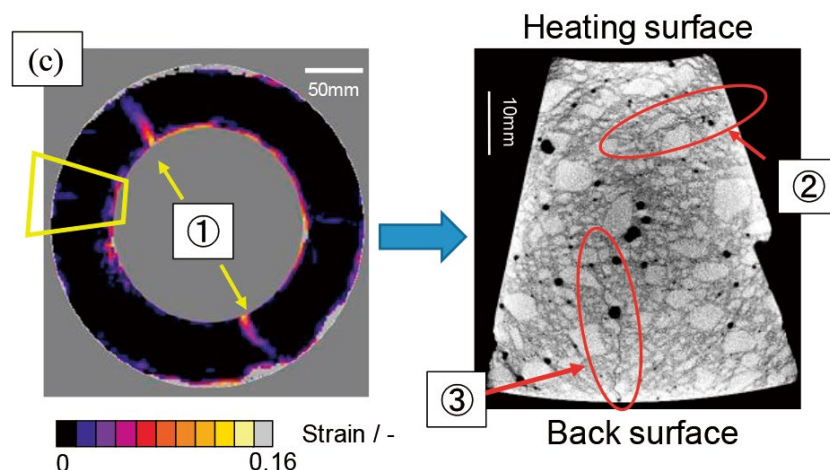
**Fig. 8 Strain distribution image with DICM in sample(c) in Fig.7 and X-ray CT image of the same sample.  
(Crack 1: 180° symmetrical vertical crack, Crack 2: parallel crack at heating surface, and Crack 3: vertical crack from the back surface.)**

次に、上から3段目のリングサンプルの一部から採取した小片のX線CT画像を図8に示す。X線CTによって内部の亀裂を確認したところ、DICMによって確認できた背面側から発生した垂直な亀裂③の他、加熱面から内部約10mmの位

Next, in Fig. 8, X-ray CT images of a small piece taken from the third section from the top of the ring sample are indicated. The X-ray CT image shows a vertical crack (3) generated from the back side, which was confirmed by DICM. In addition, a relatively small crack (2) parallel to the heating

置に、加熱面に対して平行な比較的小さい亀裂②が確認された。

surface was confirmed at a position about 10 mm inside from the heating surface.

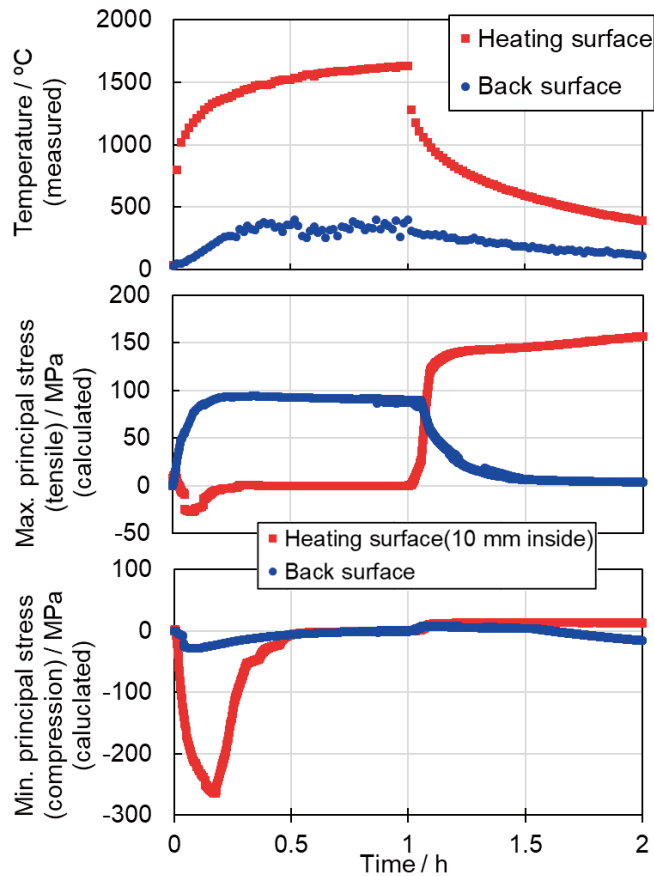
Fig. 10 Measured temperature (a) and the maximum and minimum stresses (b) and (c) calculated in the ring sample by FEM analysis.

まず加熱中の挙動について着目する。加熱面の最小主応力のグラフ(図 10(c))より、加熱開始から約 20 分後、加熱面からおよそ 10 mm 内部の位置に、約 250 MPa 程度の非常に高い圧縮応力が発生していることが分かった。また背面の最大主応力のグラフ(図 10(b))より、背面側には約 100 MPa の引張応力が発生することが分かった。これらのことから、加熱面付近に発生した平行な亀裂②は高い圧縮応力によって発生したものであること、また、背面付近に発生した垂直な亀裂③は引張応力によって発生したものと推察された。

一方で、冷却中においては、加熱面の最大主応力のグラフ(図 10(b))から加熱面側に約 130 MPa 程度の高い引張応力が発生していることが分かった。これはクリープ収縮に伴う残留引張応力が発生していることが原因と考えられる。リングサンプルは加熱中に外側を鉄皮で拘束されているため、加熱面付近に高い圧縮応力がかかった状態となりひずみが蓄積される。また、加熱面は高温であるためクリープ変形し、この時に蓄積されたひずみによって冷却時に引張応力が発生すると考えられる。よって、図 5 において各サンプルに発生した 180° 対称方向の大きい垂直な亀裂①は、このクリープ収縮に伴う残留引張応力によって生じたものと推察される。

**Figure 10** shows the results of the FEM analysis. First, we focus on the behavior during heating. The graph of the minimum principal stress on the heating surface (**Fig. 10(c)**) shows that about 20 minutes after the start of heating, extremely high compressive stress of about 250 MPa is generated at the position about 10 mm inside from the heating surface. In addition, the graph of the maximum principal stress on the back surface (**Fig. 10(b)**) shows that the tensile stress of about 100 MPa is generated. From these results, it was estimated that the parallel cracks(2) generated near the heating surface were caused by the high compressive stress at the heating surface. Moreover, the vertical cracks(3) on the back surface were considered to be caused by tensile stress.

Next, during cooling, the graph of maximum principal stress on the heated surface (**Fig. 10(b)**) shows that high tensile stress of about 130 MPa is generated. The reason of this high tensile stress is considered to be the generation of residual tensile stress due to creep shrinkage. The ring sample is constrained on the outside by the steel shell during heating, so high compressive stress is induced near the heating surface, and then strain is accumulated. In addition, the heating surface was at a high temperature, which causes creep deformation, and the accumulated strain is thought to generate tensile stress during cooling. Therefore, in **Fig. 5**, the large 180° symmetrical vertical cracks (1) in each sample are estimated to be caused by residual tensile stress due to this creep shrinkage.

リング拘束熱衝撃試験において発生した亀裂は、実機で発生する亀裂の位置と概ね一致していたが、亀裂の大小を比較すると、亀裂①>亀裂③>亀裂②となり、剥離の主原因と考えられている亀裂②(平行な亀裂)の程度は小さかった。この理由としては、応力の持続性の影響が考えられる。図10(b),(c)より、加熱面及び背面の引張応力は長い時間発生しているのに対して、加熱面付近の圧縮応力は短い時間しか発生していないことが分かる。このことから、亀裂①及び③は、亀裂が発生した後も持続的に引張応力が働くようなひずみが生じるため、亀裂が拡大する傾向を示したと考えられ、一方で、亀裂②は非常に高い圧縮応力によって発生したが、一時的なものであったため、それ以降は進展できず、亀裂が小さいまま残存したと推測される。実機で使われる耐火物は繰り返し熱

The cracks generated in the ring-constrained thermal shock test were generally consistent with the location of cracks in the ladle. However, a comparison of the size of the cracks showed that crack (1) > crack (3) > crack (2), the size of crack (2) (parallel cracks), which is considered to be the main cause of spalling, was smaller. A possible reason for this is the influence of stress durability. Figs. 10(b) and (c) show that tensile stresses on the heating surface and the back surface were generated for a long time, while compressive stresses near the heating surface were generated for only short period. Therefore, cracks (1) and (3) are considered to exhibit a tendency to grow because of the strain that caused the continuous tensile stress after the crack initiation. On the other hand, crack (2) was generated by very high compressive stress, but only temporarily, thus it is assumed that the crack could not grow thereafter and remained as a small crack. Actually, the refractory materials used in ladles are repeatedly exposed to thermal shock, thus it is considered that spalling is
